CASE: OH-CLO

January 2, 2012: Over the next weeks we will be performing a complete overhaul of a Lycoming O-320-D2J engine from a Finnish Cessna 172, reg. OH-CLO.

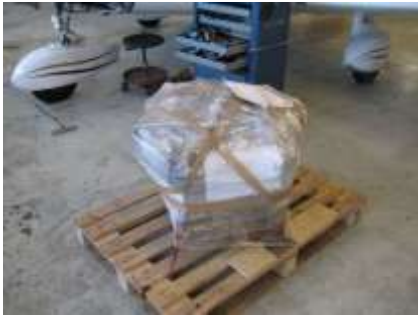
Step A: Engine arrives via truck from Finland, and is being prepared for dismantling in the piston engine shop

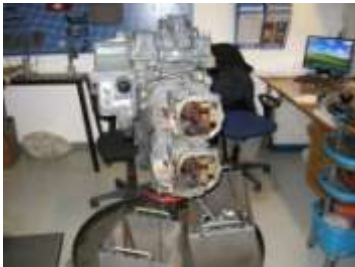
Step B: Dismantling of engine in progress. It's important to inspect the vital components very quickly to assure they can be reconditioned within manufacturers specifications.

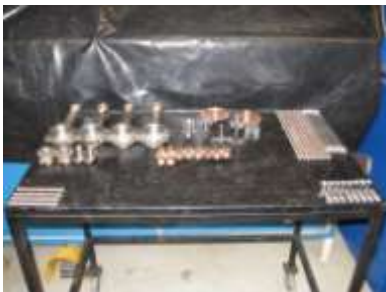
Step C: While the crankcase had to be reworked in the States, the appropriate internal steel parts undergoes a Magnaflux-Inspection (NDT). This is performed in our own Magnaflux Test Bench.

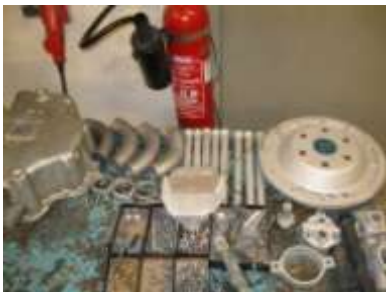
Step D: While waiting for the re-worked crankshaft, all the remaining components and parts are ready for installation.

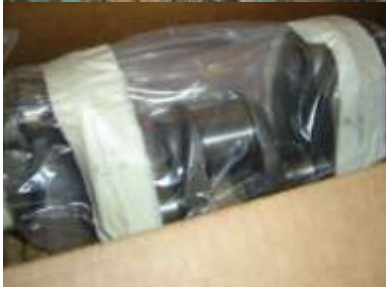
Step E: After a delayed re-work, the crankshaft finally arrived, and the re-assembly of the engine is back on track!

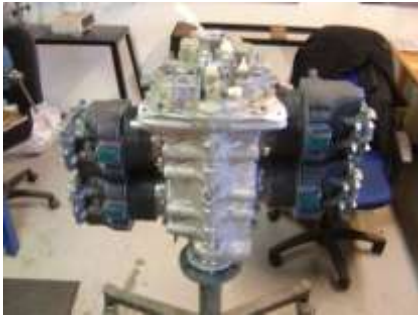
Step F: Engine being re-assembled with new factory-parts, and then primed before final painting.

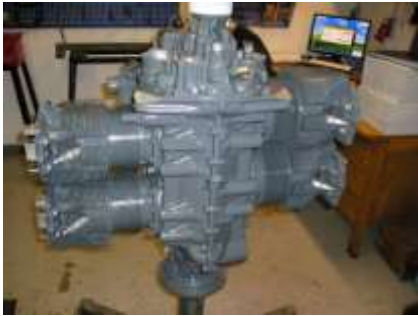
Step G: Engine ready for final assembly, after completion of painting.

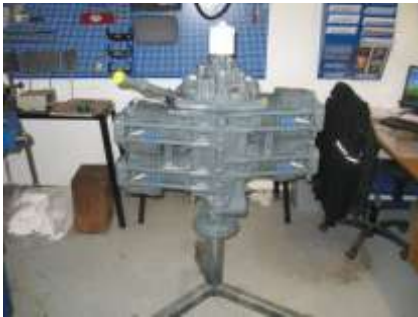
Step H: The engine is now assembled, and waiting to be installed in the test vehicle for first runup.

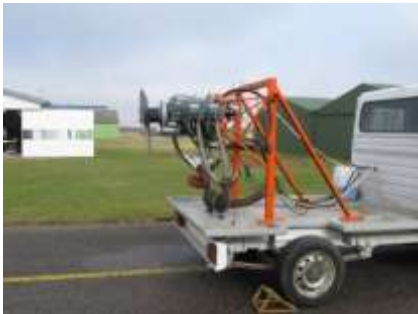
Step I: Engine placed in the test stand, and final check performed before the testrun. During test run, all necessary run-in data is captured and listed.

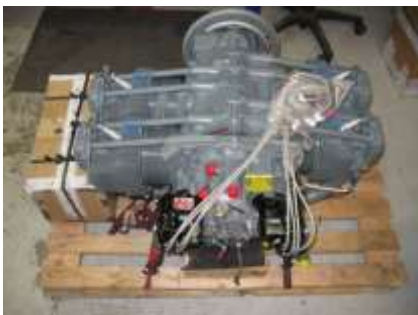
Step J: Engine overhaul completed, and engine is ready for shipment back to Finland.
